FACILITY COMPLIANCE INSPECTION REPORT

Division of Waste Management Solid Waste Section

Date of Site Inspection: 28 December 2011 **Date of Last Inspection:** 23 December 2011

Miller Farm LCID Landfill
 Miller Farm Road
 Morehead City, NC 28557

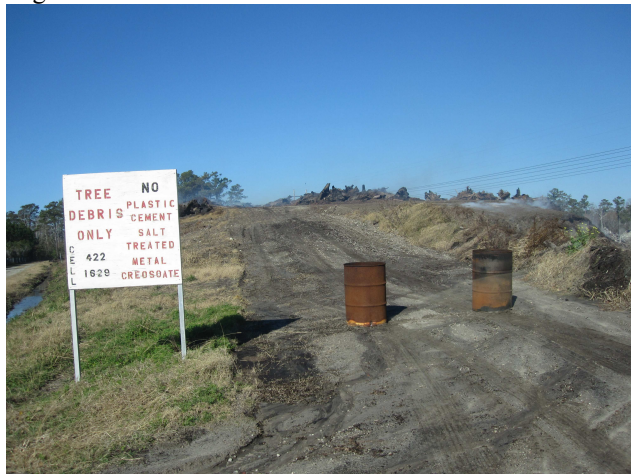
- 13) No fire suppression activities were observed during this site visit.
- 14) The facility operator has blocked the access road at the landfill entrance for safety.

Access blocked at landfill entrance

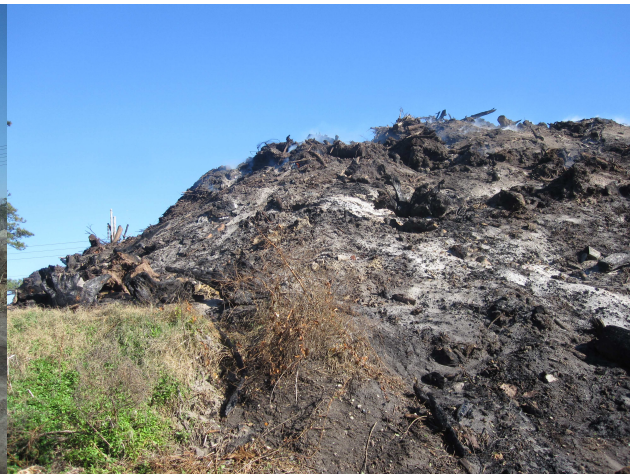
- 11) Soil has been stockpiled for use as cover adjacent to the landfill access ramp.
- 12) Recent rains have done a lot to reduce the amount of smoke coming from the fire; however, smoke was still noted as emanating from various areas throughout the facility during this site visit.

Landfill cover crop and cap damaged by fire and equipment

- 18) *As soon as is safely practicable, please begin pumping water onto the landfill, with specific attention being given to the areas where smoke and/or flames are noted as emanating from the landfill cap. In past similar events, excavating these "hot" areas and dousing them directly with water has proven to be the most effective way of fighting these types of fires.

- 19) *As soon as is safely practicable, please resume compacting and covering the landfill cap and sideslopes damaged during the fire incident. Once the repairs are completed, all sideslopes should be graded at a slope not greater than 3:1 and seeded and mulched to establish a groundcover suitable to prevent erosion.

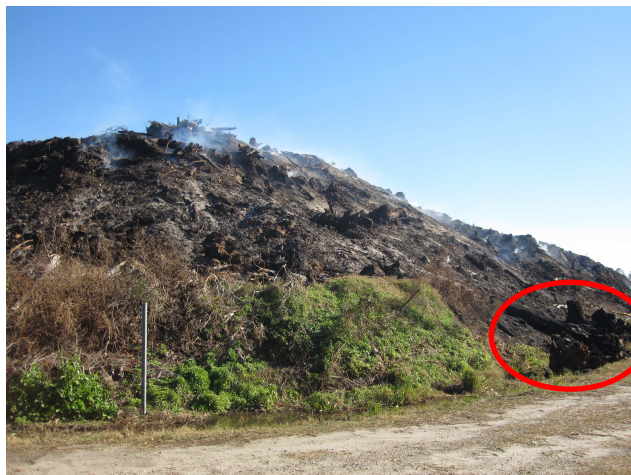
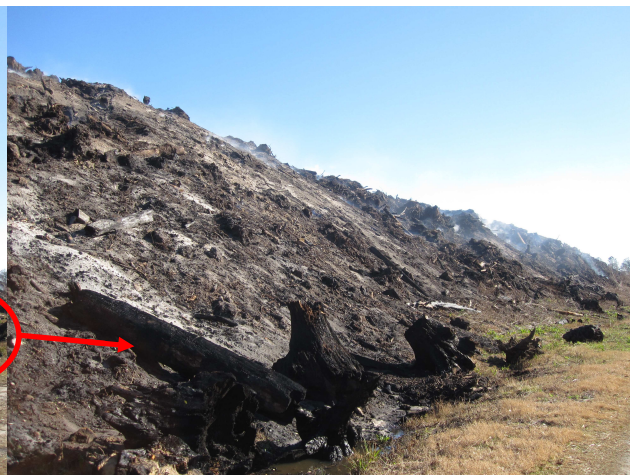
- 15) The facility operator stated that he had used an excavator to dig out as much woody waste from the burning areas as he was safely able to reach and then roll the material down the sideslopes to prevent further spreading of the fire. Charred and smoking stumps were observed at various places around the sideslopes and the toe of the sideslopes where they had been dug out and rolled away from the burning areas.

Cover crop and cap damaged by fire and equipment –note debris removed from burning areas and rolled away from the fire at the sideslope toe
